# Recent Work on the Land Walls of Istanbul: Tower 2 to Tower 5

METIN AHUNBAY AND ZEYNEP AHUNBAY

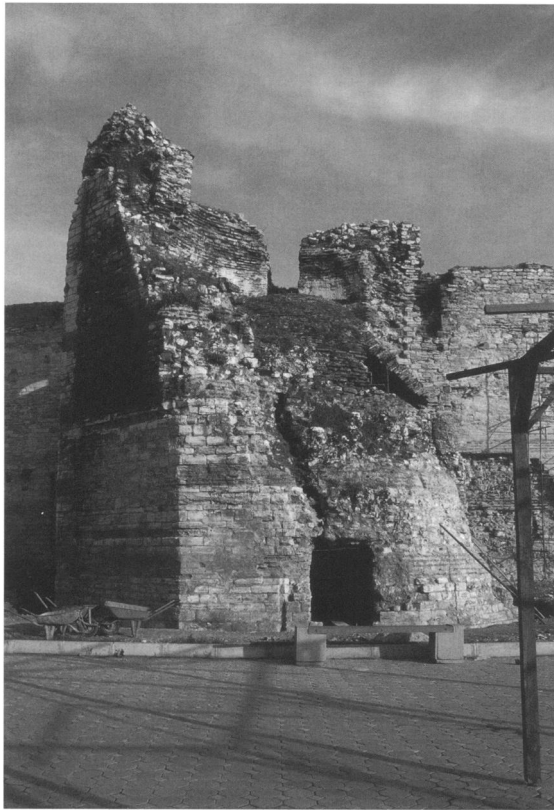
3 Istanbul, tower 2 from the west, 1991

The second tower (T2) presented serious structural problems (Fig. 3). Its octagonal form had been damaged by earthquakes and mutilation by the tanneries. A passageway

had been bored through the west side to provide for easy access into the tower from the tanneries. Having lost its outer facing and weakened by cracks, the masonry on the south side had become loose and dangerous. More than a quarter of the dome covering the ground floor had been lost. At the northern side, the upper half of the tower was partially intact, with scanty remains of an upper dome. The upper parts of the southeastern, southern, and southwestern walls were totally lost.

The tower stood as an impressive ruin that merited preservation as it was. Yet, its structural instability necessitated measures against further losses. In order not to change the behavior of the historic structure, insertion of foreign elements during the strengthening operation was restricted to a minimum. The weak parts of the wall were stabilized and the missing portion of the lower dome was restored, returning the tower's structural integrity. Vertical cracks on the walls were stitched, and a reinforced concrete beam was inserted on top of the northern side of the tower, to hold the tall structure together.

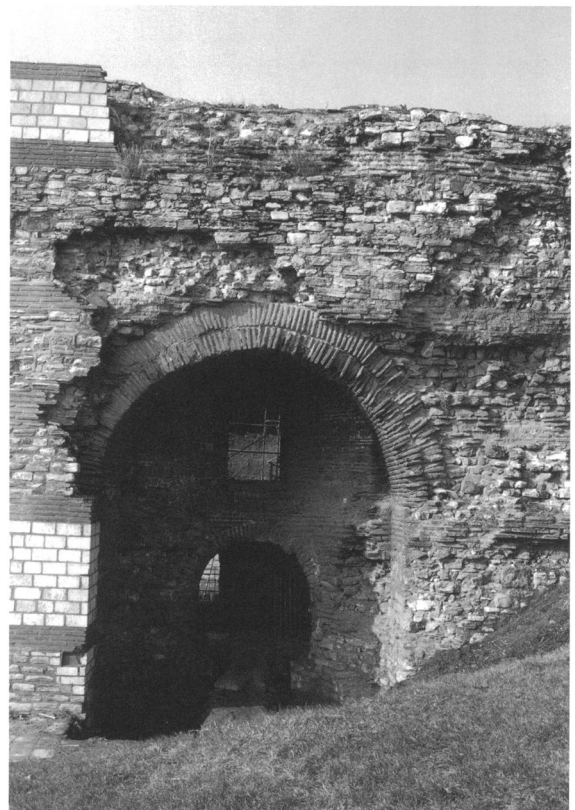
4 Istanbul, entrance to Tower 2, 1991

Entrances to the towers are generally from the east, through vestibules crowned by brick arches, resting on attached piers (Figs. 4, 6). As observed in many of the towers along the main circuit of the land walls, the collapse of the vestibule arch had resulted in dangerously cantilevered wall sections above the entrance to T2. Considering the difficulty of preserving the stone blocks in position, the vestibule arch was reconstructed using bricks produced especially for this restoration.

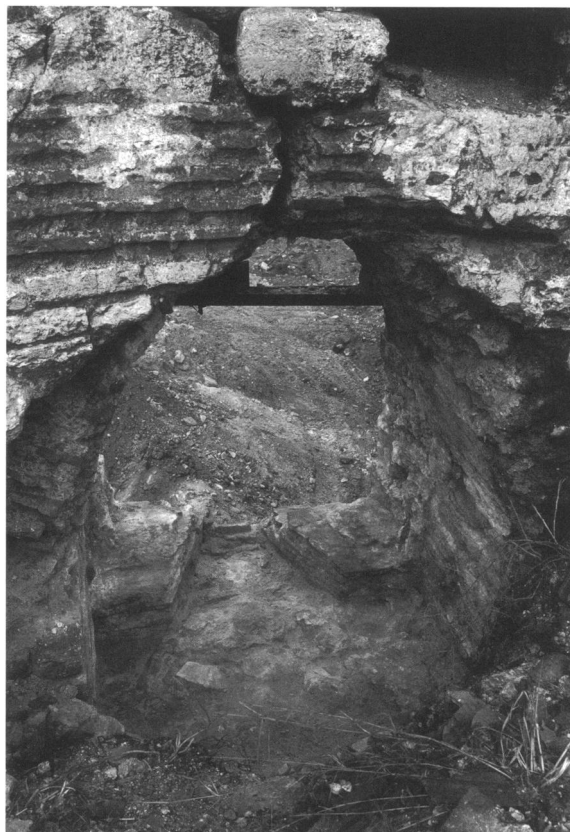
5 Istanbul, remains of the loophole at the north wall of Tower 2, 1992

On its northern side, the tower had a loophole that had been unrecognizably mutilated by the tannery. Cleaning and excavation within the window niche provided evidence about its original form and size (Figs. 5, 7). It measured 29.5 to 30 centimeters wide at the facade, and the lateral walls splayed out into a wide niche in the wall thickness. Vestiges of a similar window were found on the west elevation of the tower. During the restoration of the western facade, the outer facing was raised to the base of the dome, and the western window was partially reconstructed, using the northern one as a model.

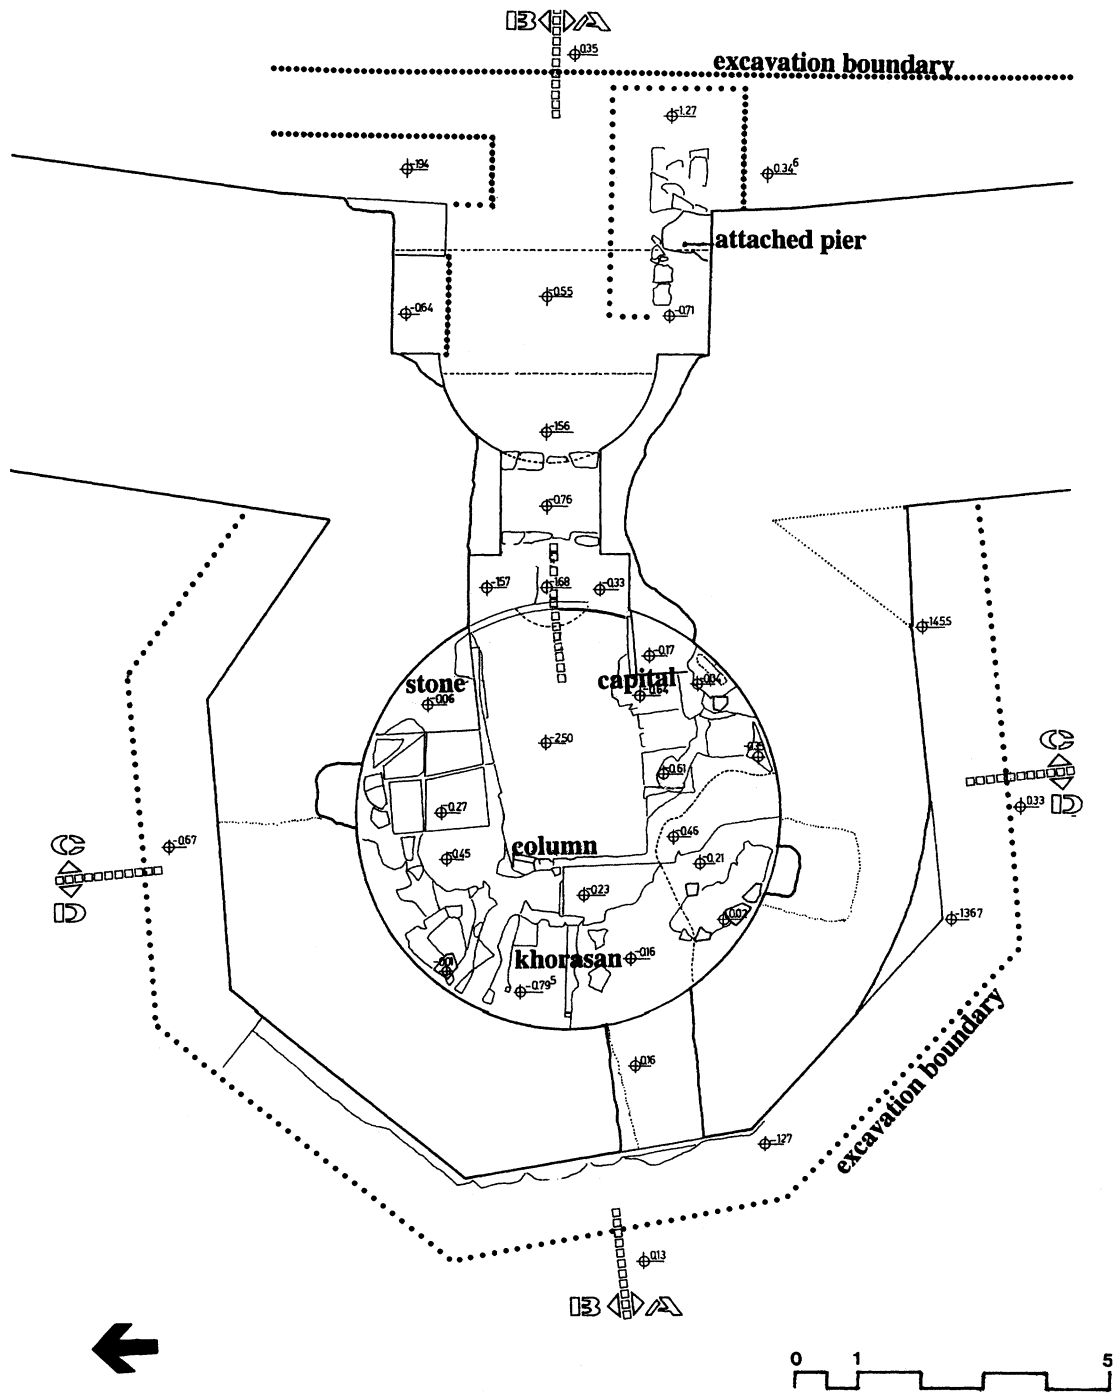
6 Istanbul, Tower 2, ground-level plan, 1992

repair operation, during which the marble blocks were arranged in such a way that they surrounded three sides of a small rectangular area (Figs. 6, 8). The fact that the original entrance level from the vestibule was maintained during this operation suggests that the purpose was not to raise the floor level but to strengthen the structure.

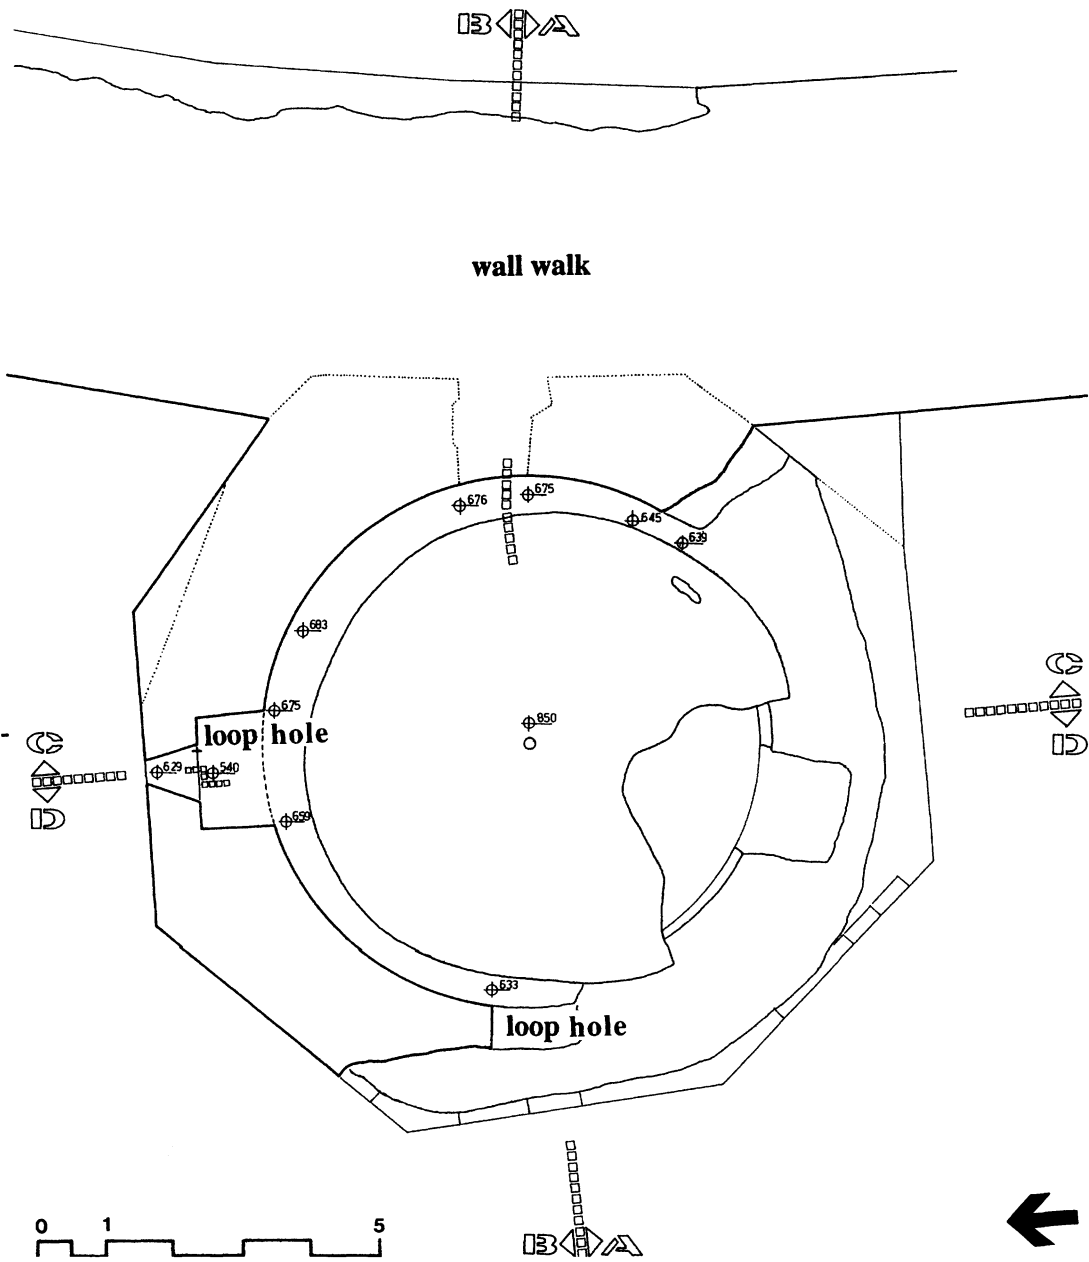
7 Istanbul, Tower 2, plan of upper chamber, 1992

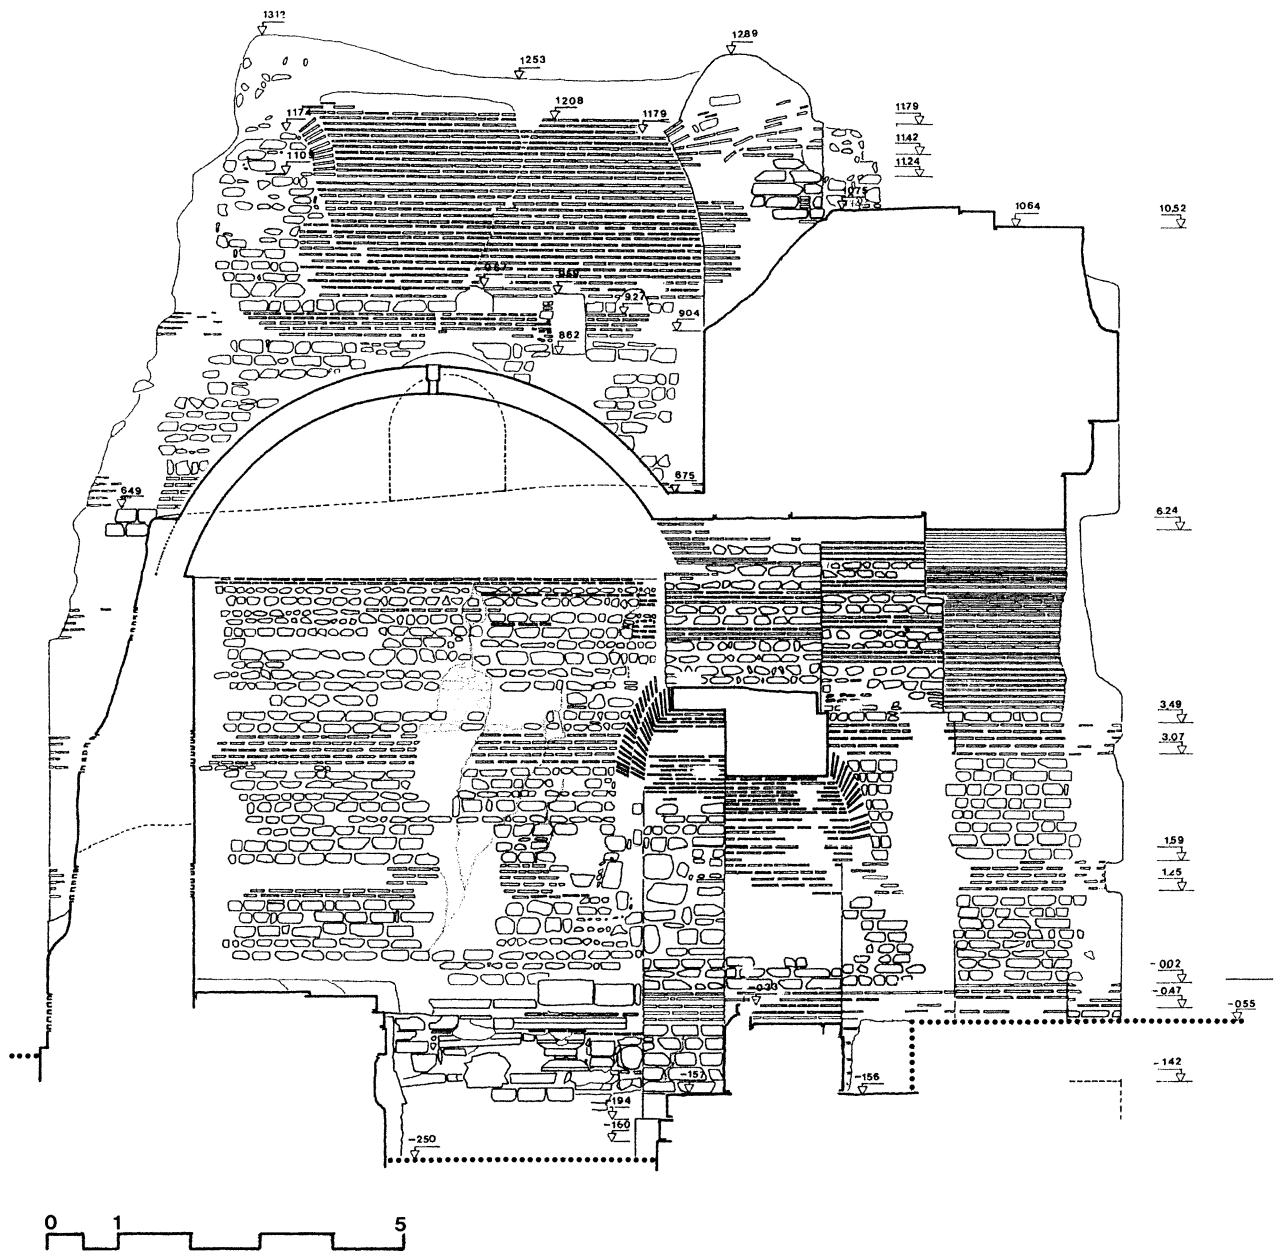
8 Istanbul, Tower 2, east-west section, looking north, 1992

Apparently the lower dome of T2 was a later addition, for it blocked the loopholes (Fig. 8). The present dome shell rests on a setback of the inner cylinder, above which the tower has a wider interior diameter. Originally, the setback must have supported a timber floor flush with the sill of the window niche (Fig. 9). Thus the loopholes did not serve as light sources for the ground floor but were apertures for archers or arrow- or bolt-shooting machines positioned in the upper room.

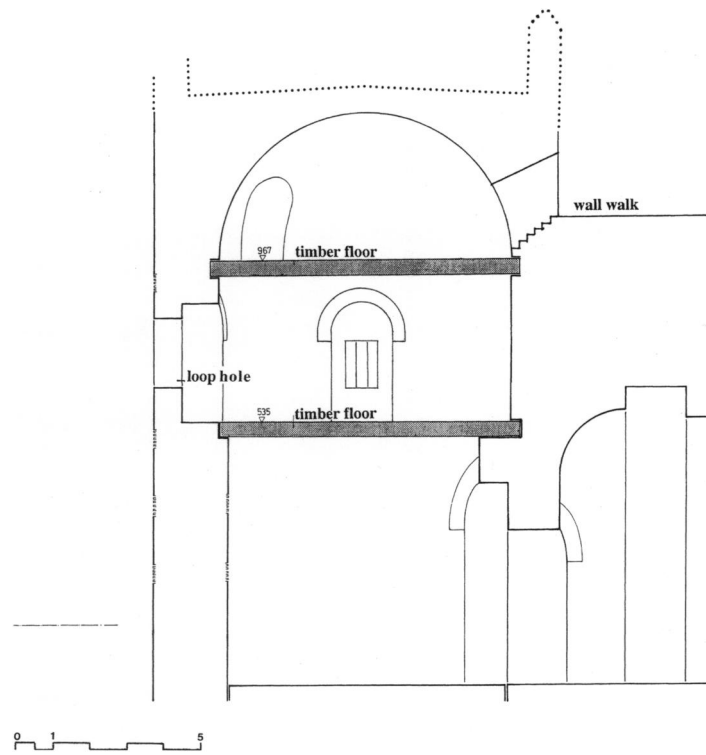
9 Istanbul, Tower 2, east-west section, looking north, reconstruction drawing

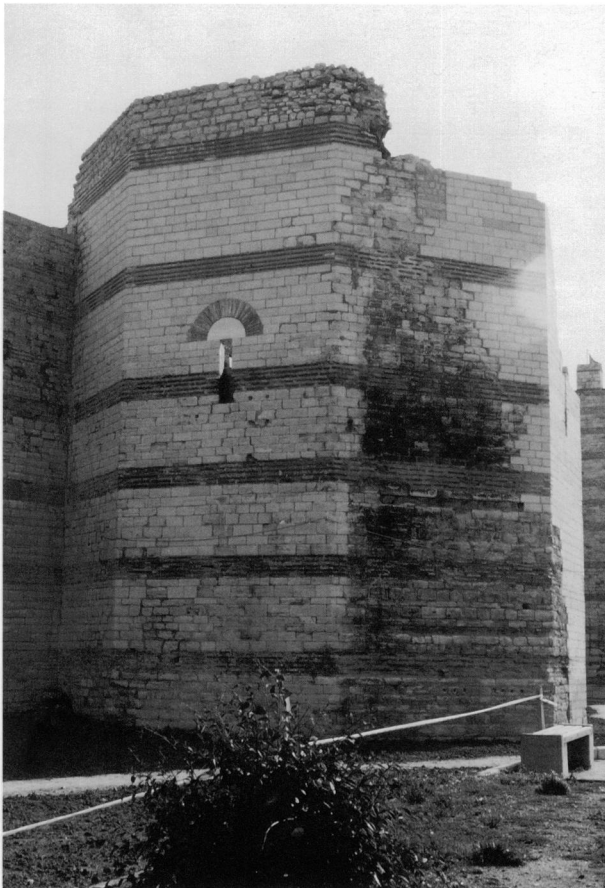
10 Istanbul, Tower 2 from the northwest, after restoration, 1993

At a higher level on the northwest facade, enough had remained to prove the presence of a window, filled in at a later date with rubble stone (Fig. 10). Its brick vault is preserved on the inner side of the dome. It probably accommodated heavier artillery, such as a large catapult. Sockets for timber beams just below the base of the upper dome and at the same level as the window are indications of a second room with a timber floor. The position of the window at the northwest side of the tower shows that two or, at most, three artillery machines were employed in this room, which was confined within the hemisphere of the original dome. Access to this floor is from the rampart walk, through a passage leading down to the chamber (Figs. 8, 9). The passage was covered by an inclined vault; remains of its brickwork are visible in the masonry.

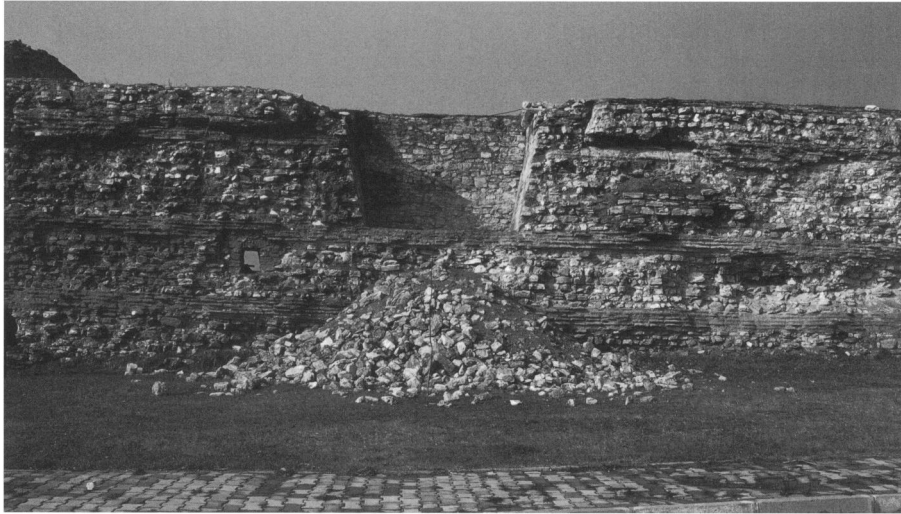
11 Istanbul, trapezoidal opening on the eastern side of the wall between Tower 2 and Tower 3, before restoration, 1992

A peculiar intrusion in the form of a trapezoidal opening disrupts the regular course of the curtain wall at a point close to T2 (Fig. 11). This gap is visible from the east, while a thin wall screens it from the field side. The breach was probably a later defensive measure intended to isolate a strategically important section.<sup>11</sup> The slanting walls of the opening

exhibit a different masonry technique from that used elsewhere. Bands of three brick courses alternate regularly with five courses of squared blocks, sheathing the exposed rubble core of the curtain wall on either side of the interruption. This new rhythm in the refacing is extended to the field side of the curtain wall toward T2. A very hard, pink mortar pointing was used in the joints around the squared blocks, enclosing them in rectangular frames. The regular alternation of brick and squared block courses suggest Palaiologan style. A similar fabric was used in the upper level of Mermer Kule (the Marble Tower), which has been tentatively identified with a Palaiologan princely residence.<sup>12</sup> Consequently, the wall section up to T2 can be considered as an extension of Mermer Kule.<sup>13</sup> During examination of the wall walk between T2 and the V-shaped opening, cavities left by deteriorated timber beams and their missing traverses were partially uncovered under the much-repaired and disturbed floor tiles. They are probably remains of a palisade built to protect the rampart walk in front of T2 against attack from the field and from the northern side of the V-shaped gap. This might be a further indication of the defensive nature of the intrusion.

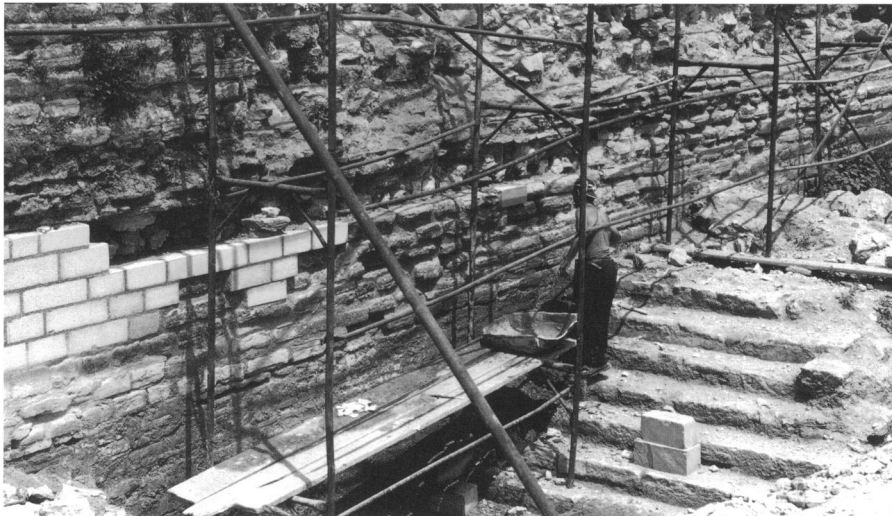
12 Istanbul, remains of double stairs on the eastern side of the wall between Tower 2 and Tower 3, 1992

Excavation on the ground level along the eastern side of the main wall revealed the remains of double stairs leading to the rampart walk above T3 (Figs. 12, 14). This is an element not documented in Meyer-Plath and Schneider's survey. Only the lower parts of the stair and the springings of the vaults supporting the stairway were preserved *in situ*. They provided information about the original ground level at this side of the wall, as well as details about the stair construction. The masonry of the stairs was not bonded with the main wall, perhaps explaining the loss of the upper parts. The vault supporting the stairs was made of brick, while several large stone blocks were laid out to form the steps. No attempt was made to reconstruct the whole structure; only the missing blocks of the steps were replaced, and the ruin was stabilized.

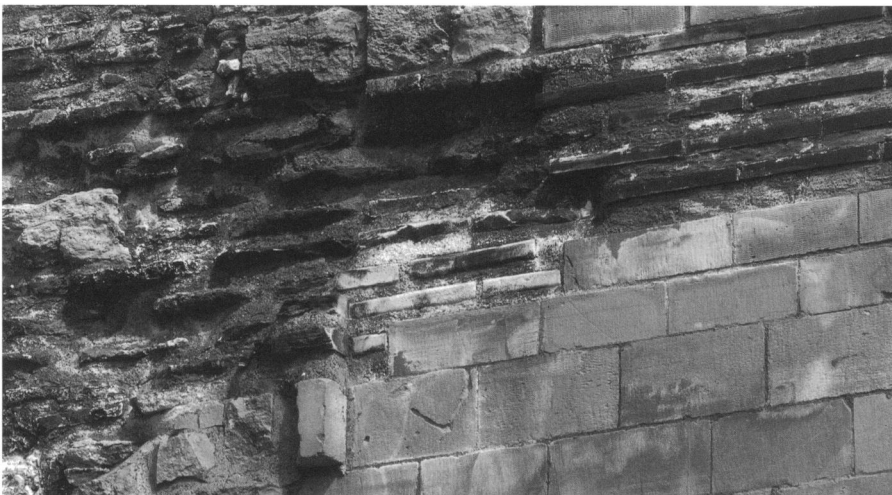
13 Istanbul, brick band with eight courses at the juncture of Tower 3 with the curtain wall, 1992

An interesting detail was observed at the point where the south wall of T3 joined the curtain wall. One of the brick bands, third from the top, has eight brick courses (Fig. 13). The unusual number of brick courses at this point is explained by the meeting of brick bands from two adjacent structures, curtain wall and tower. The lower three courses of the band belong to the south side of T3; the two courses directly above are shared by both structures. This awkward transition from the tower to the curtain wall and the abrupt interruption of some brick courses after they join the curtain wall seems to have been intended to achieve a strong bond between the tower and the curtain wall—contrary to the advice of the military theoretician Philo of Byzantium,<sup>14</sup> who advised against bonding two elements of a fortification in order to avoid possible damage resulting from differences in settling. Brick bands act as both stiffeners along the walls and bonding agents between the facing blocks and the wall's rubble core. Inserting brick courses, even par-

tially, into the masonry of an adjoining structure established a strong bond. Whether it was adequate is less certain.

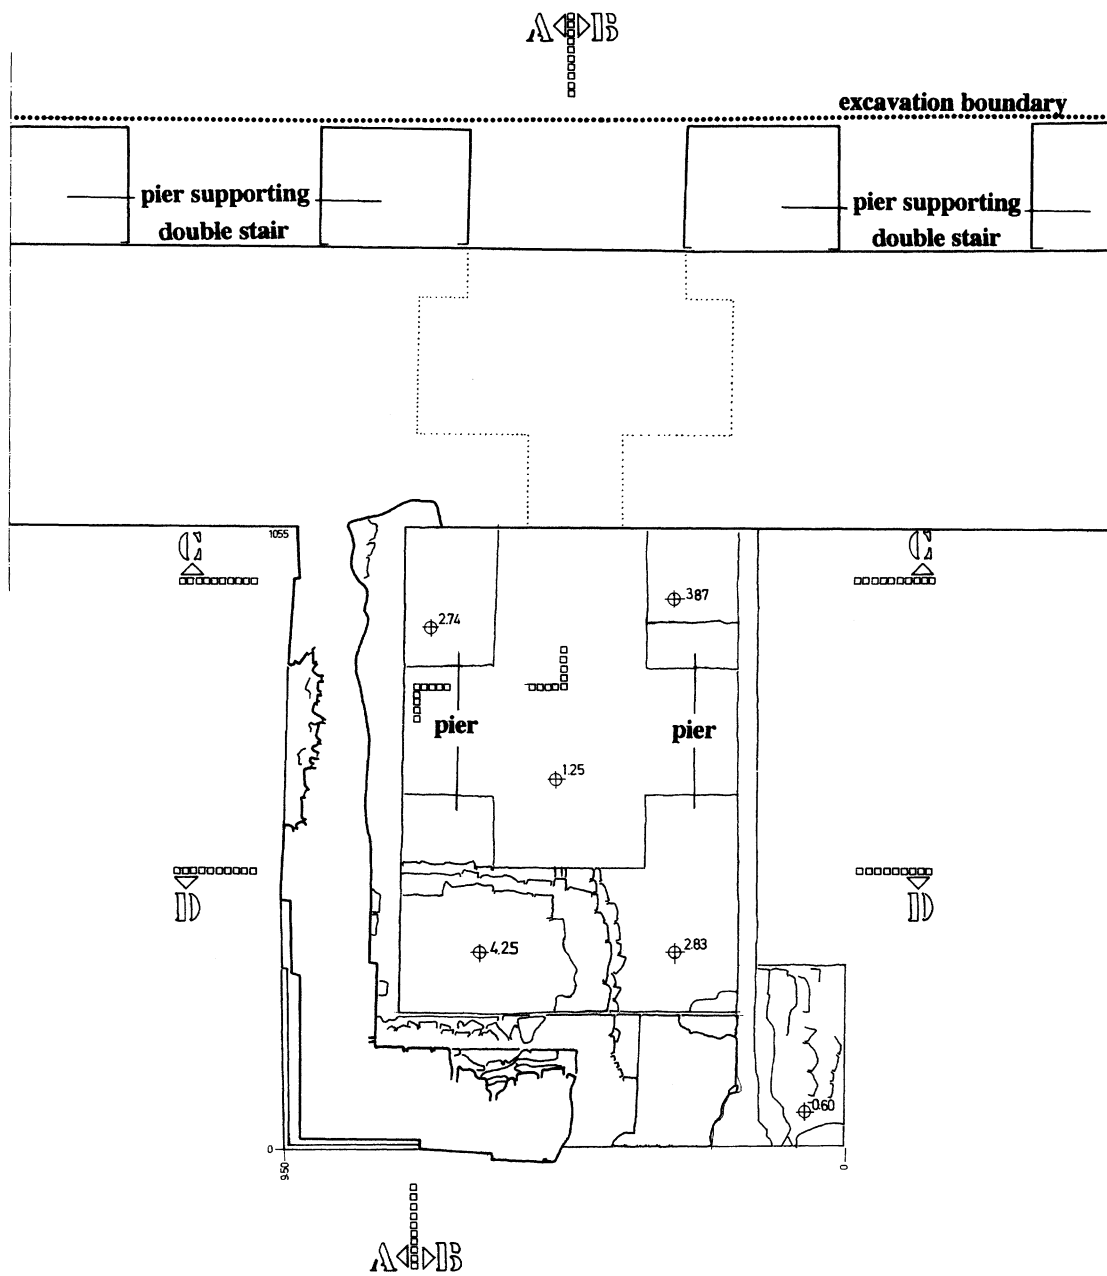
14 Istanbul, plan of Tower 3, before restoration, 1993

Only half of the western wall was preserved (Figs. 14, 18). Its stone and recessed brick construction indicated a repair from the eleventh and twelfth centuries. By excavation, it was possible to reveal the southwest corner of the tower and a small portion of the south wall, which had fifth-century fabric intact. During restoration, the southwest corner of T3 was raised enough to project above the ground, so that the full perimeter of the tower would be visible, revealing its rectangular plan (Fig. 19).

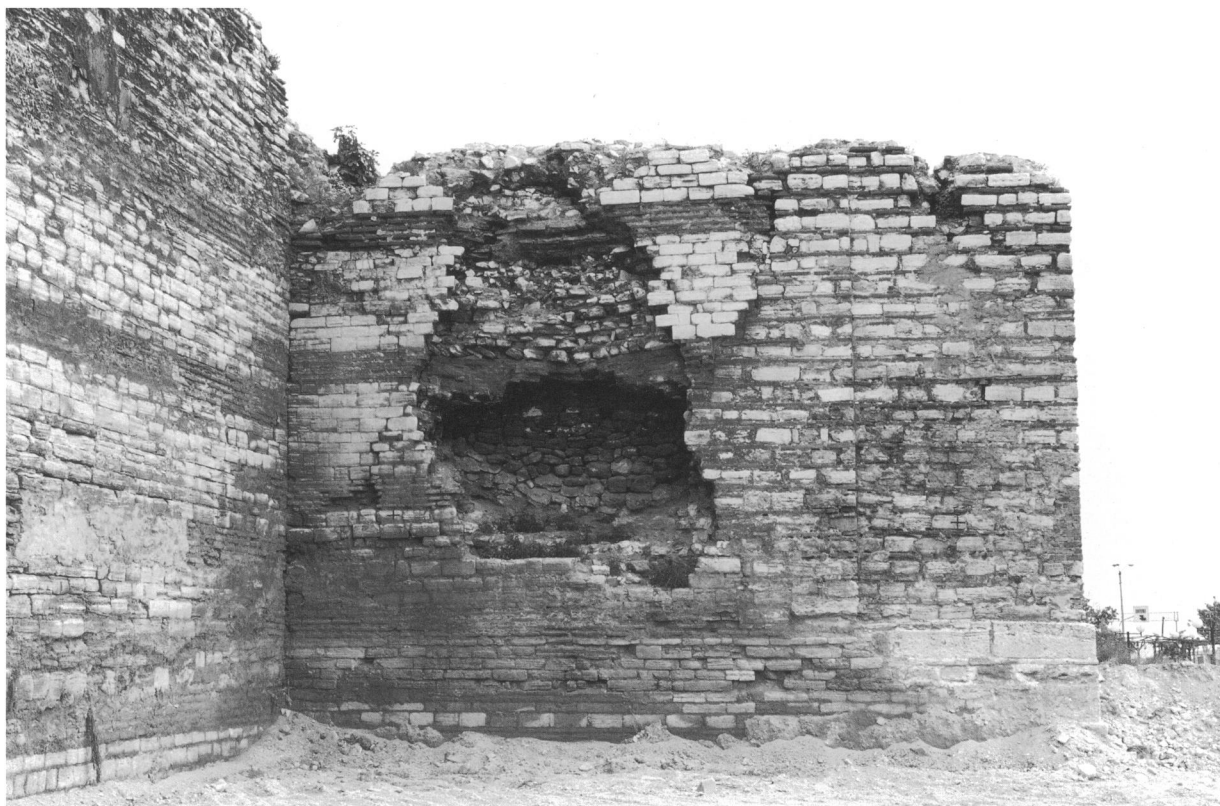
15 Istanbul, north wall of Tower 3, before restoration, 1992

Although the northern wall of the tower had large areas dating from the Middle Ages, the evidence indicated that the large cavity on this elevation was limited to a portion from the fifth century (Fig. 15). During the repair, the original masonry techniques were used to rebuild the missing courses (Fig. 16).

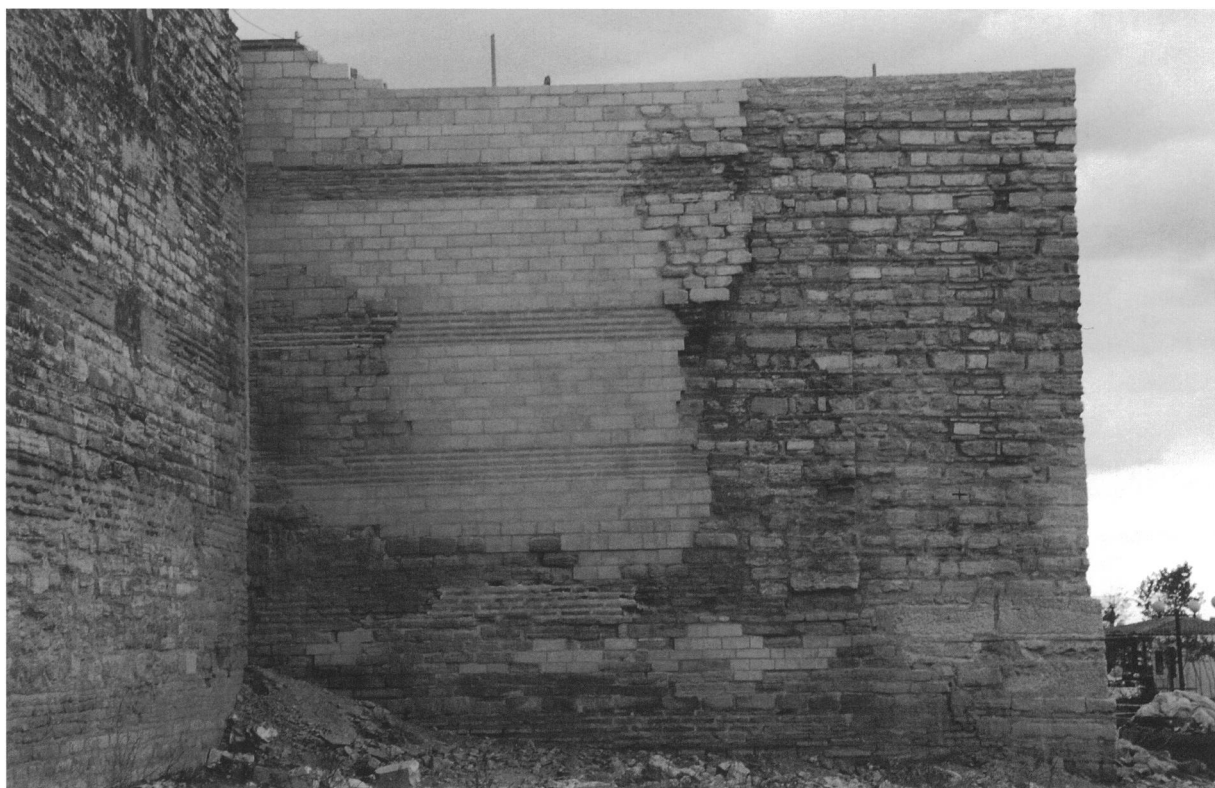
16 Istanbul, north wall of Tower 3, after restoration, 1993

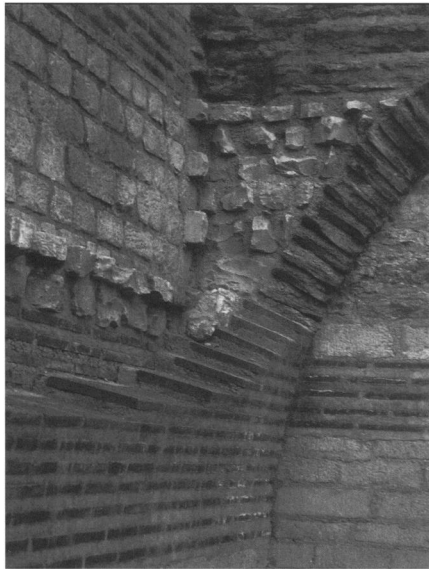
17 Istanbul, detail from the restoration of Tower 3, 1994

The wall above the gateway leading from the vestibule to the interior of the tower had largely collapsed. The gateway arch had to be rebuilt as part of the reconstruction of the eastern wall. A reinforced concrete beam was inserted above this arch to relieve the load of the masonry above. The original barrel vault over the ground floor had left its mark on the eastern wall; during restoration, its contour was retraced (Fig. 17).

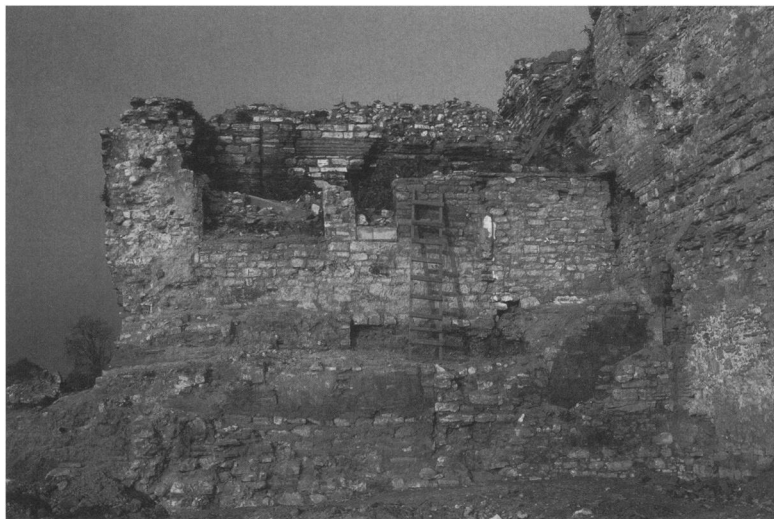
18 Istanbul, Tower 3 from the south, before restoration, 1991

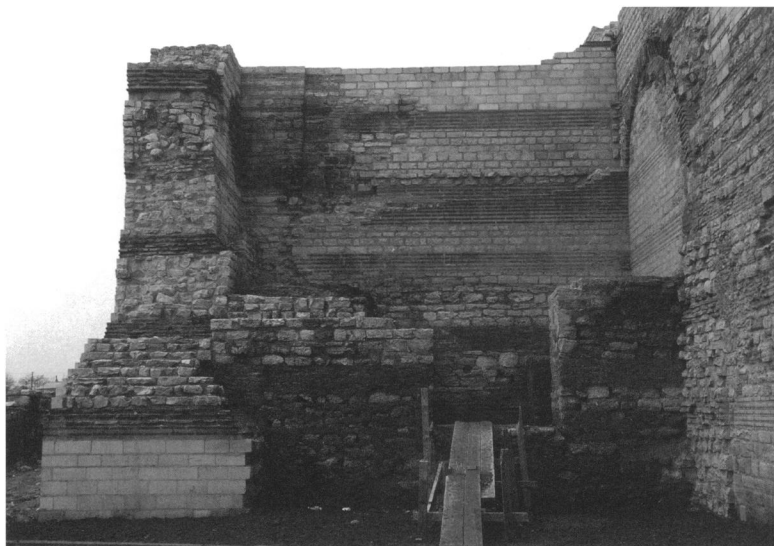
19 Istanbul, Tower 3 from the south, after restoration, 1994

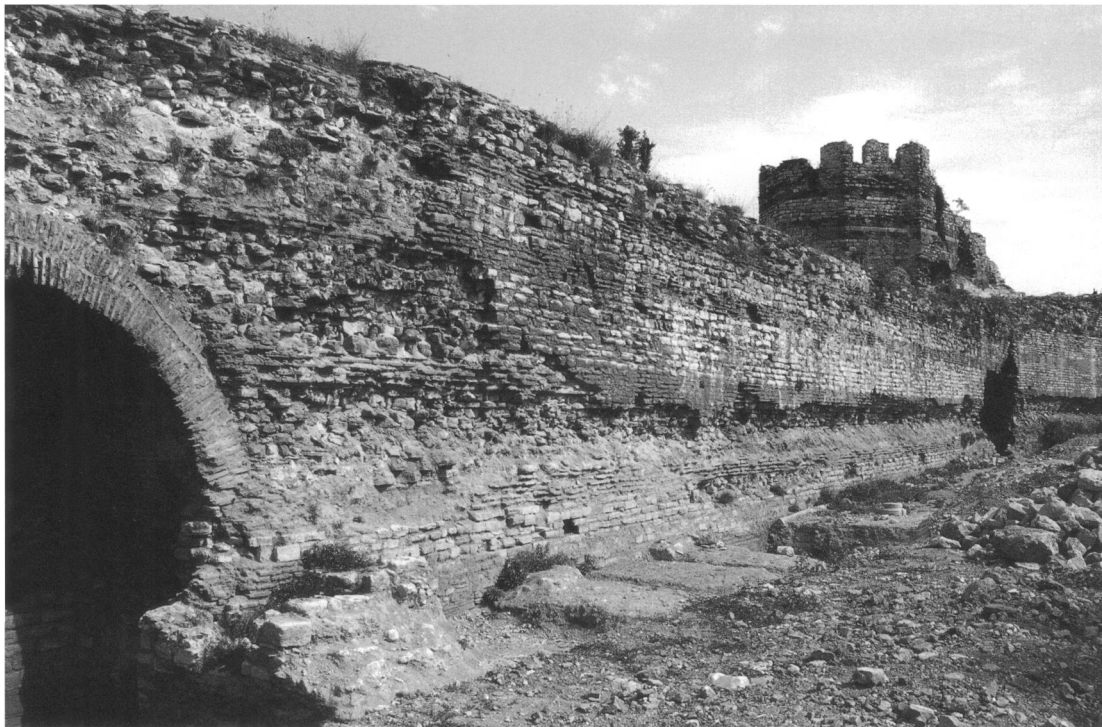
20 Istanbul, east side of wall between Tower 3 and Tower 4, before restoration, 1992

The city side of this wall section had a nearly horizontal band of damage within the fifth-century fabric (Fig. 20). Near the entrances to T3 and T4, the damaged surface widened, due to the collapse of the crowning arches of the vestibules and loss of their supporting piers. The wide band of missing courses, where the depth of the lost masonry was almost one meter, was repaired using material and workmanship similar to the originals. The upper levels of the wall had late Palaiologan repairs, which are distinguished by their roughly hewn stone blocks and insertion of some brick fragments into horizontal joints of the brick bands. This wall section was repaired using similar block sizes, surface texture, and pointing technique as the original.

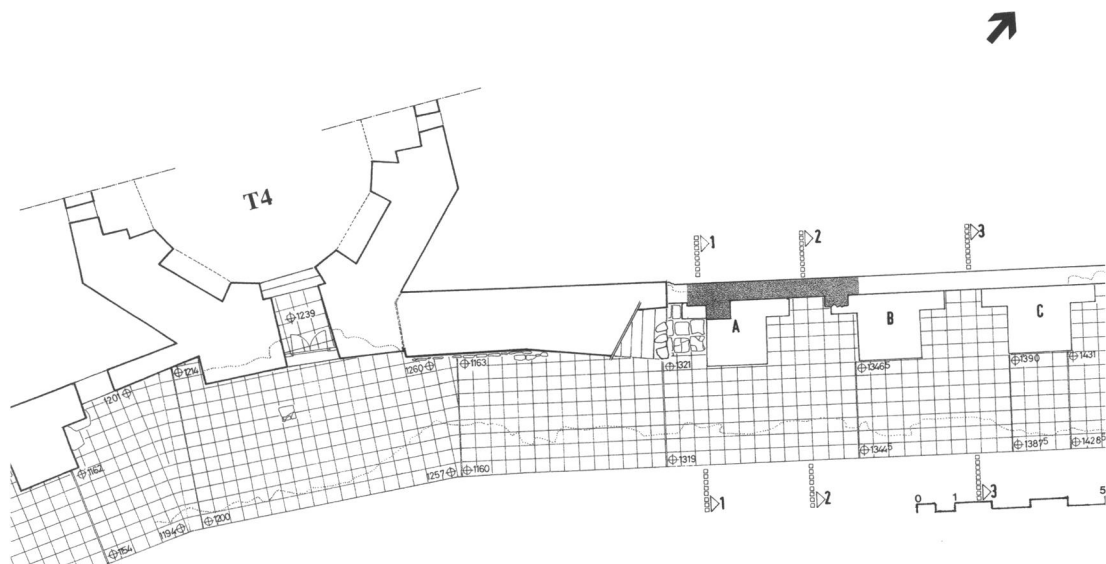
21 Istanbul, plan of the wall walk between Tower 4 and Tower 5

Decorated marble spolia used within the masonry of the battlements provide evidence that the T-type battlement was not part of the original construction. At points between T4 and T5 and T3 and T4, where the T-type battlements were severely disturbed, the stone parapet yielded information about the earlier construction. The parapet wall has inward projections, each measuring ca. 60–62 centimeters wide and 50 centimeters deep. The fine finish of the blocks indicates that the whole inner face of the parapet was exposed to view. Though the projections were preserved only randomly, it was possible to measure the distance between two successive pilasters, connected by an unbroken line of parapet construction, as 2.50 meters (Fig. 21).

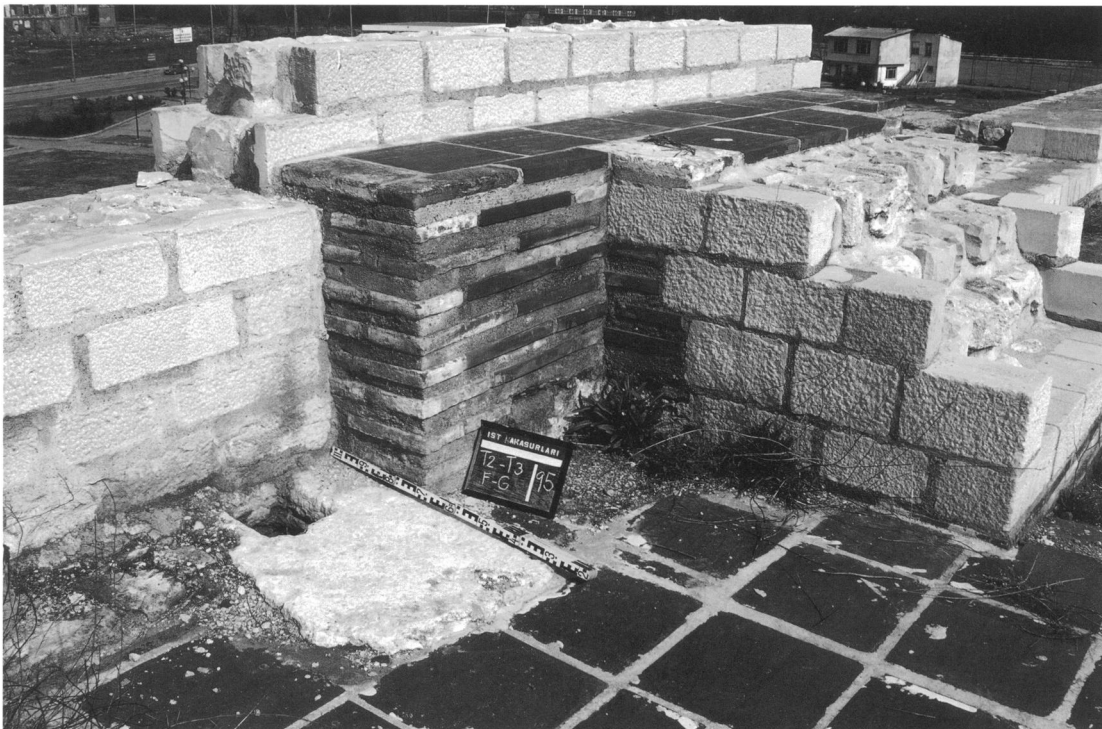
23 Istanbul, a flagstone and remains of a battlement on the wall walk between Tower 2 and Tower 3, 1995

In addition to the analogy with the outer wall, further evidence from the wall walk supports the existence of a covered battlement on top of the main wall. Within the brick floor of the rampart walk, were uncovered thick flagstones with rectangular sockets (Fig. 23). They were observed mainly between T2 and T3, but several others have been detected and documented elsewhere, up to T6. These were placed very close to the parapet, but their positions were not quite in line with the embrasures between the T-type battlements. It can, however, be inferred from the matching spans of the parapet projections and stone slabs that the flagstones were evenly positioned between the parapet piers and were part of the earlier battlement system. The perforations in the flagstones extended as far as the five-coursed brick floor, that is, approximately 40 centimeters vertically. The sockets and perforations probably served to fix the vertical supports of catapults employed on the walk level. Although it is not certain which type of catapult engine was used, these weapons could have been heavier than those employed in the outer wall.<sup>17</sup>

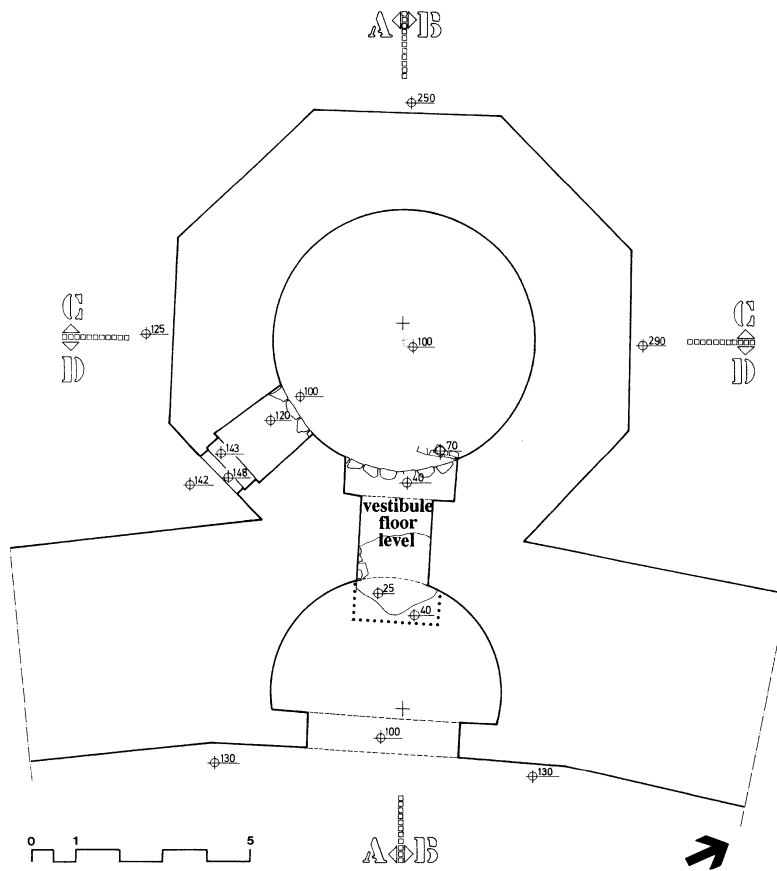
25 Istanbul, Tower 4, ground-level plan, 1993

After clearing the entrance to the tower, excavation continued inside to the level of the original floor (Fig. 25). A postern connecting the tower to the peribolos (the inner terrace between the main and outer walls) was revealed. At ground level, interior of the tower is circular in plan, while the upper chamber is octagonal, with deep recesses on each side (Fig. 26). Nothing remains from the original floor covering of the upper chamber. Curiously, there is a circular hole in the center of the floor. The most serious damage to the structure is a diagonal crack that starts above the window level on the western facade and runs down about 6 meters after turning 45 degrees from the horizontal.

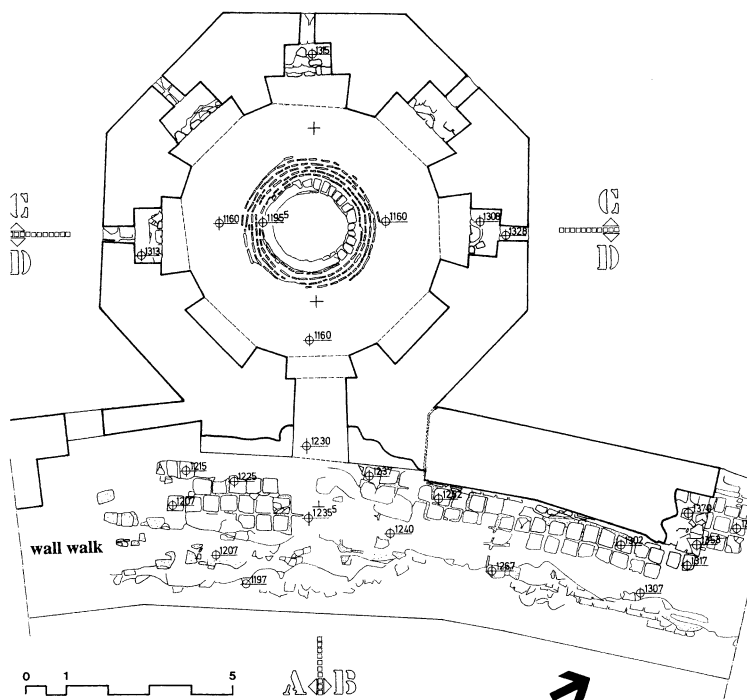
26 Istanbul, Tower 4, plan of upper chamber, 1993

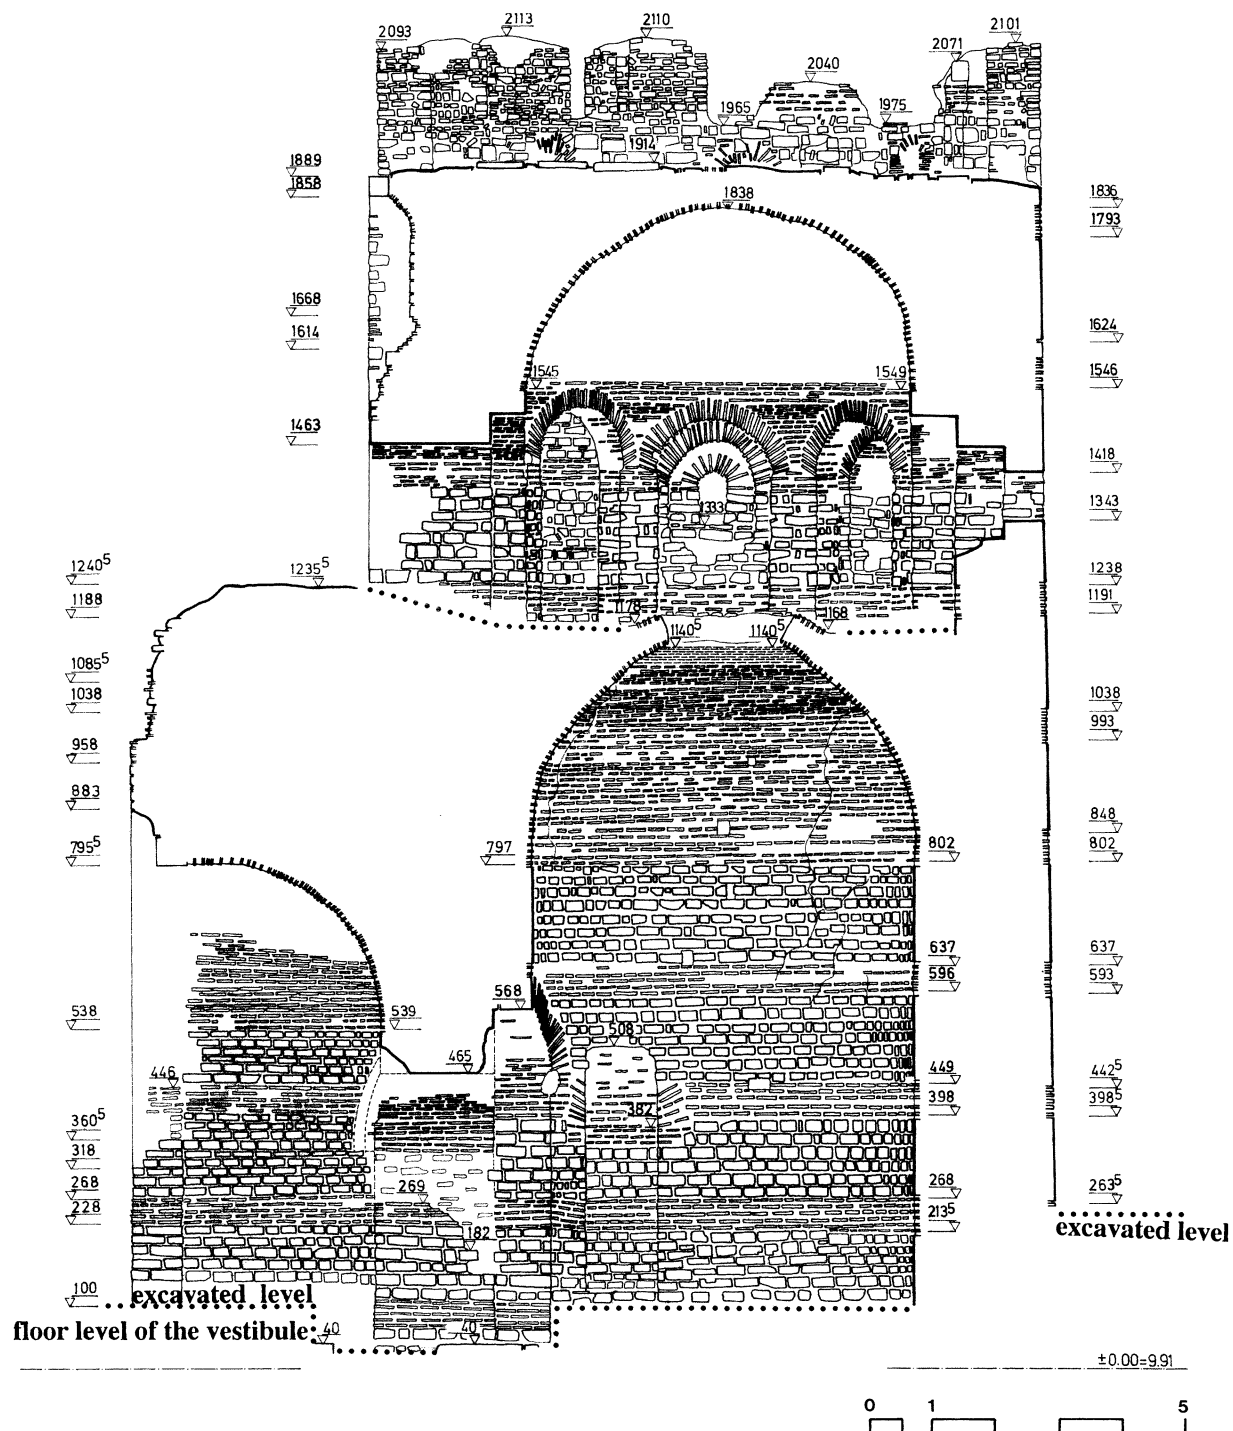
28 Istanbul, Tower 4, east-west section, looking south, 1993
